# ROSS CREEK FLOOD STUDY BASE-LINE FLOODING ASSESSMENT

**Volume 1**  
MAY 2013

Document    Ross Creek Flood Study - Base-line Flooding Assessment

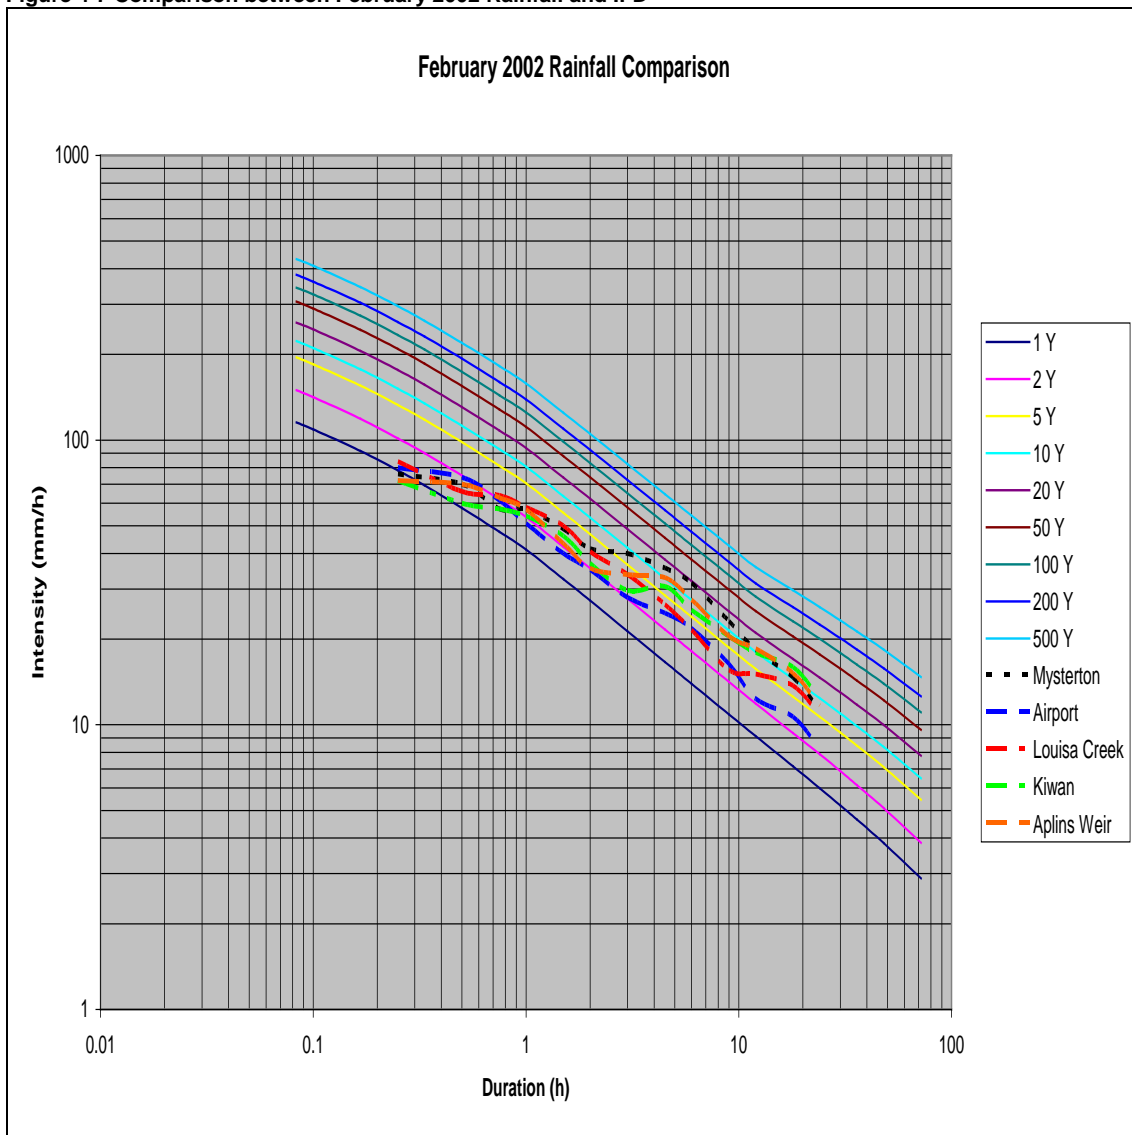
Figure 4-7 Comparison between February 2002 Rainfall and IFD

The February 2002 event was a moderate rainfall event that occurred over the 13<sup>th</sup>, 14<sup>th</sup> and 15<sup>th</sup> of February 2002. Between 300mm and 450mm of rainfall fell at various rainfall alert stations throughout the Townsville area. The rainfall alert gauges relevant to the Ross Creek catchment that recorded data during the event were Mysterton, Townsville Airport, Louisa Creek, Kirwan and Aplins Weir. A comparison between the recorded rainfall at the various gauges and the IFD relationship for Ross Creek (refer to **Figure 4-7**), shows that the event was up to a 20 Year ARI rainfall event, particularly for the 6 hour duration event.

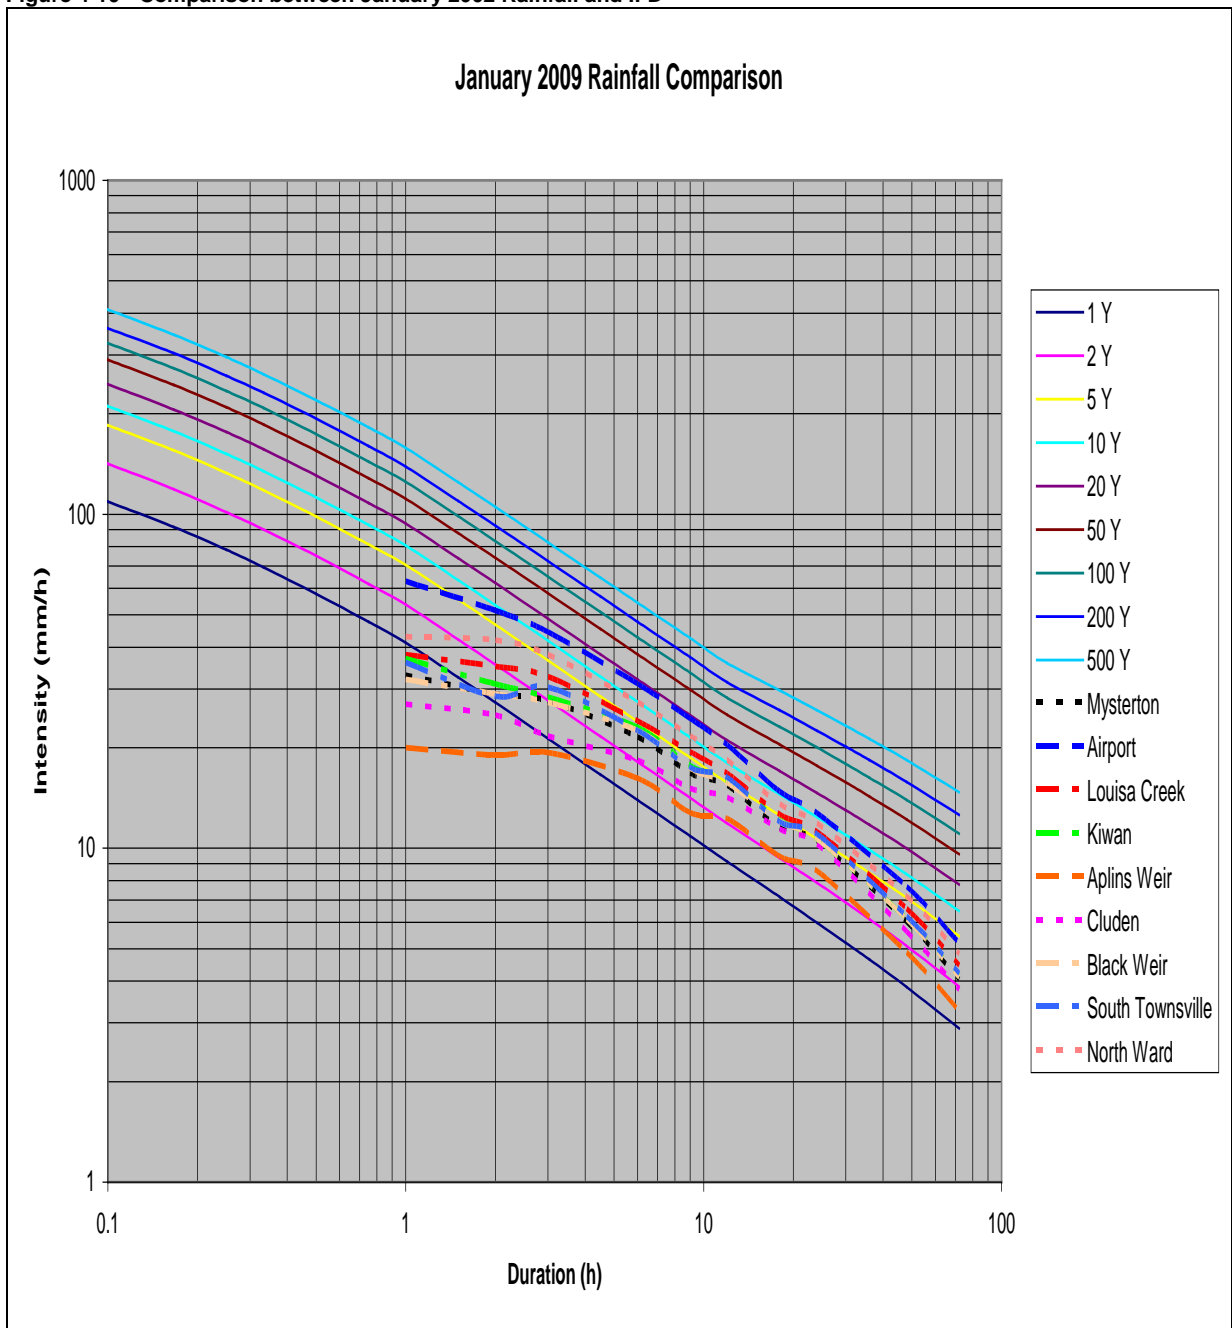
**Figure 4-10 - Comparison between January 2002 Rainfall and IFD**

The January 2009 event was a moderate event that involved flows in Ross River with rainfall on the local Ross Creek catchment. Flows over the Ross River Dam spillway started on the 29<sup>th</sup> of January 2009 and continued until the 16<sup>th</sup> of February 2009. Over this time there was also a significant rainfall event on the Ross Creek catchment between the 2<sup>nd</sup> of February and the 6<sup>th</sup> of February. The rainfall alert gauges relevant to the Ross Creek catchment that recorded data during the event were Mysterton, Townsville Airport, Louisa Creek, Kirwan, Aplins Weir, Cluden, Black Weir, South Townsville and North Ward. A comparison between the recorded rainfall at the various gauges and the IFD relationship for Ross Creek (refer to **Figure 4-10**), shows that the event was between a 2 and 20 Year ARI rainfall event with most gauges showing the event to be slightly higher than a 5 Year ARI particularly for the 12 hour duration event.

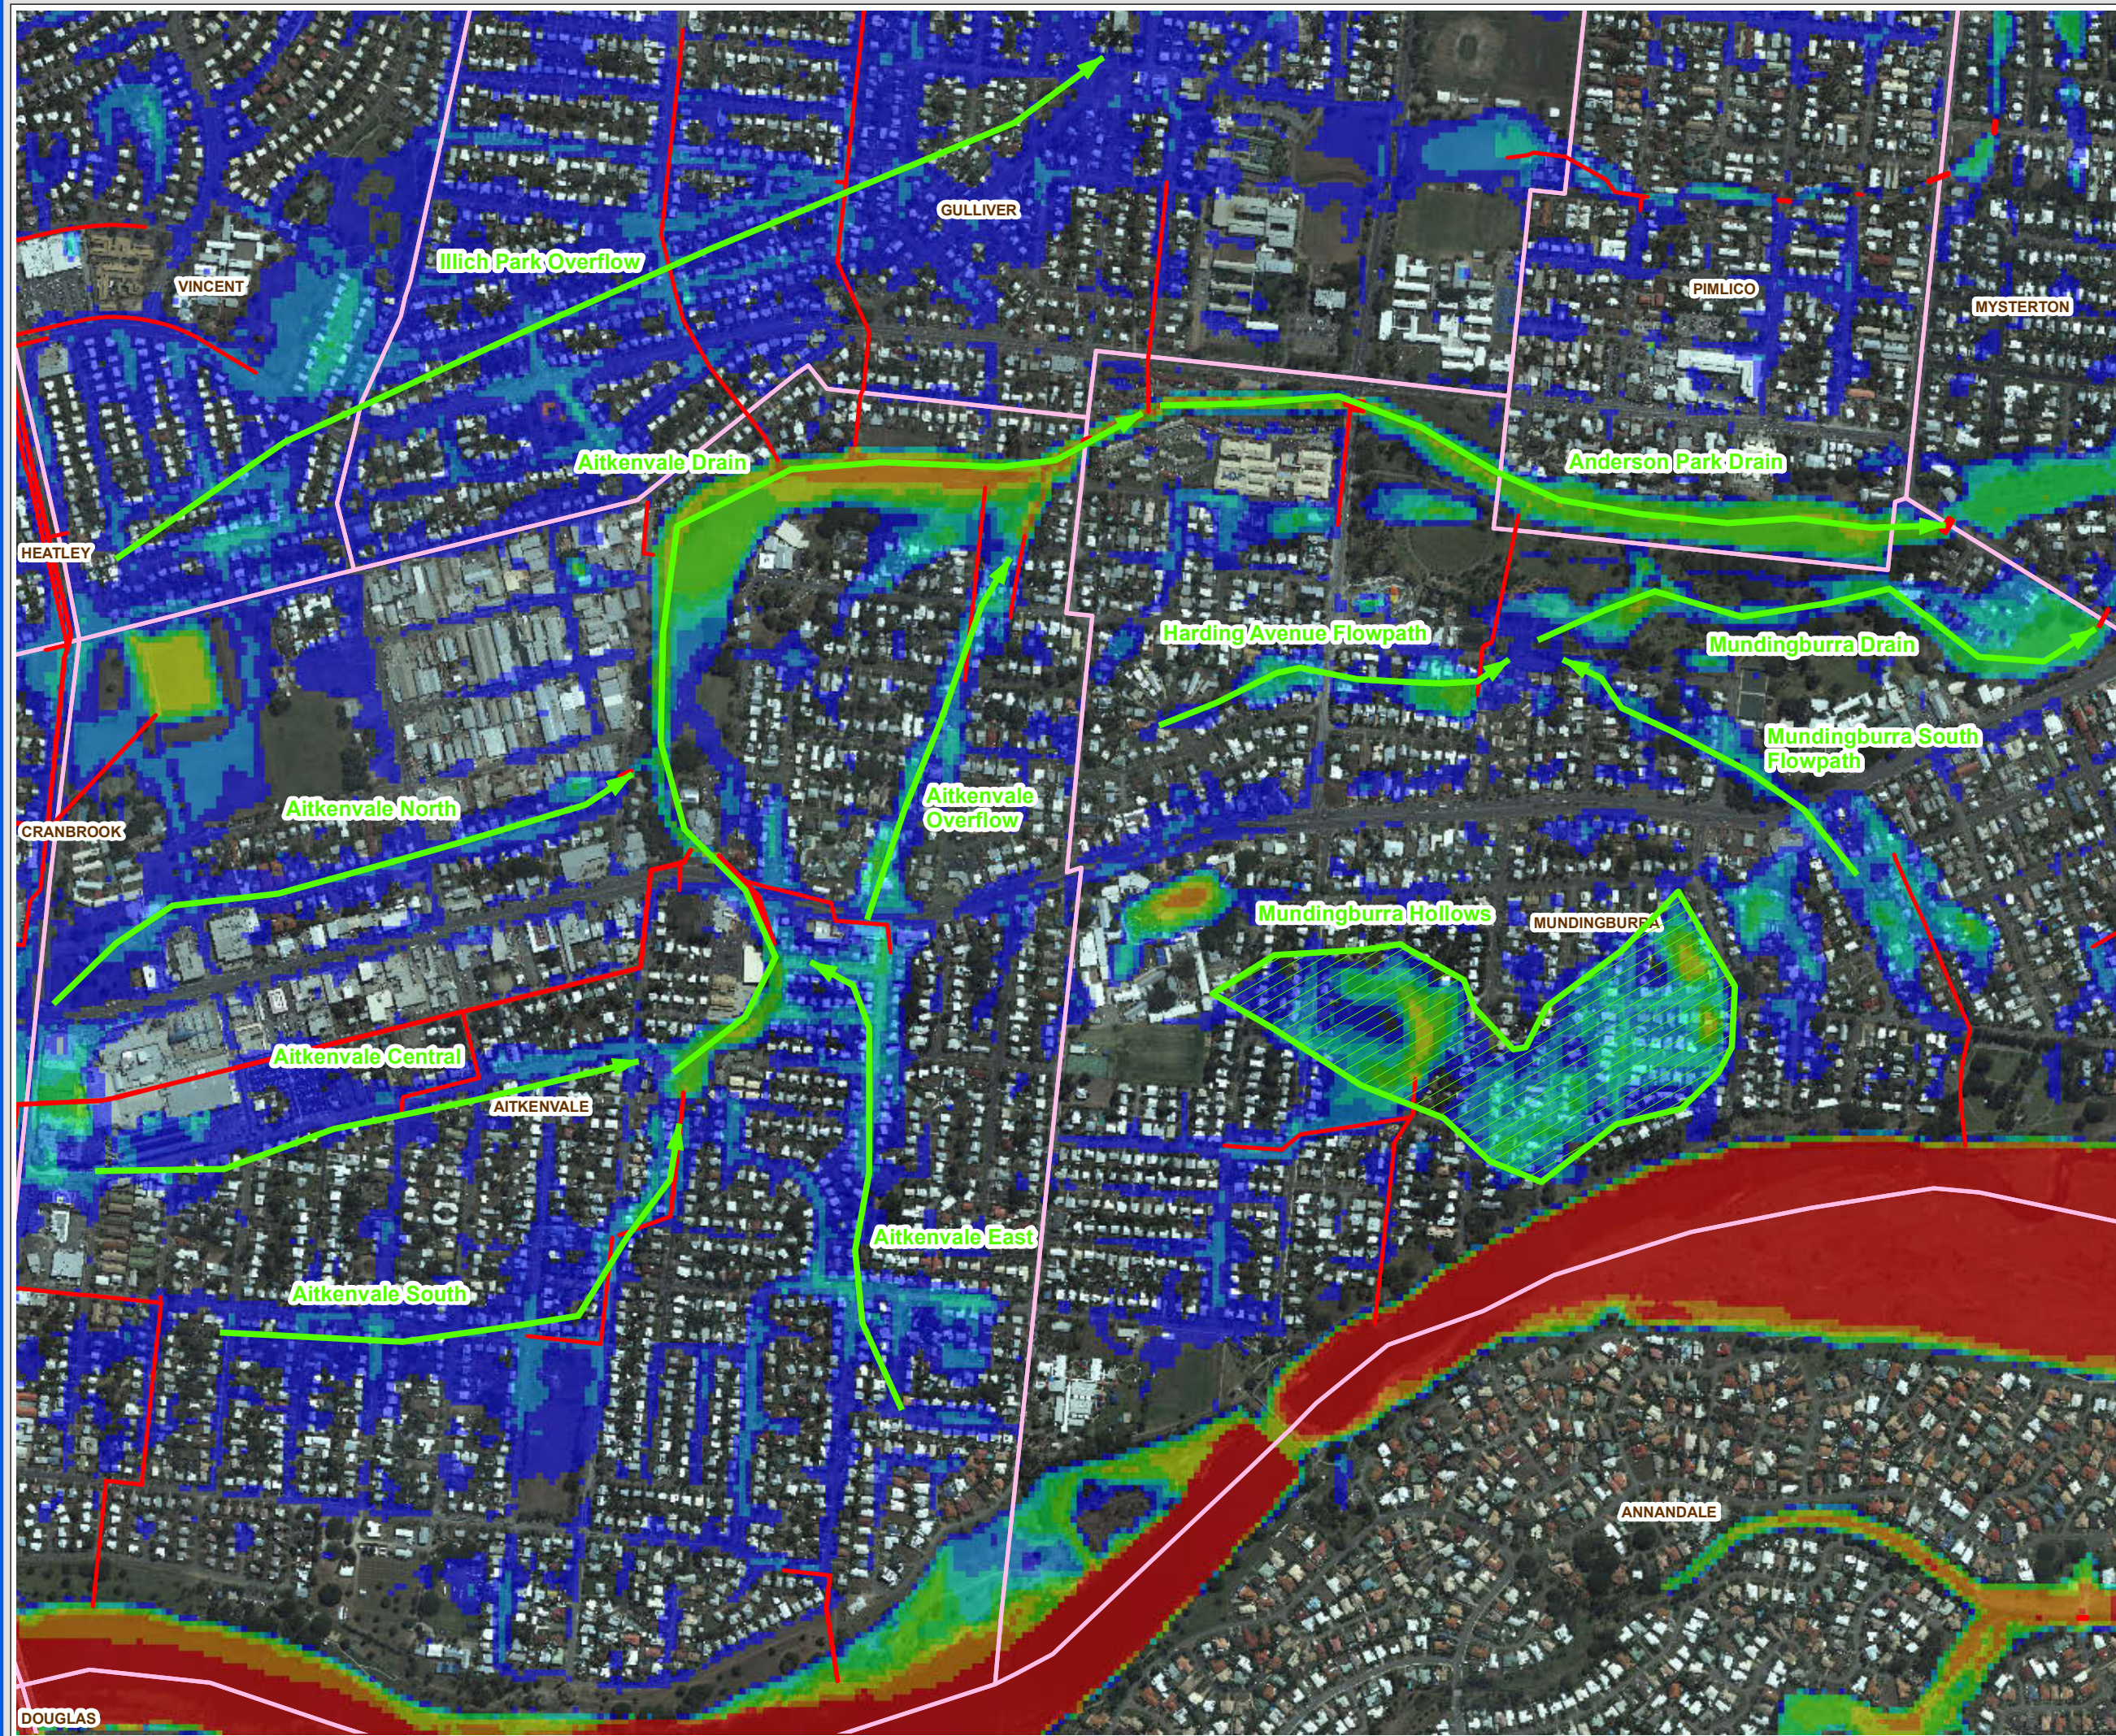
**ROSS CREEK  
FLOOD STUDY  
KEY FEATURES**  
Figure 5-2  
Aitkenvale/Mundingburra

**Figure 5-2** outlines the key drainage features of the Aitkenvale/ Mundingburra area. There are a series of major open drains and major flow paths for the area:

- Aitkenvale Drain which runs within the Parkland between Ross River Road and Armit Street and flows into Anderson Park Drain;
- Anderson Park Drain runs within Parkland between Armit Street and Balls Lane;
- a series of major surface flow paths through Aitkenvale that discharge to Aitkenvale Drain (identified as Aitkenvale North, Central, South and East in **Figure 5-2**);
- an overflow from the Aitkenvale Drain System upstream of Ross River Road adjacent to the Vale Hotel that crosses Ross River Road and flows through residential properties and streets to short circuit a majority of the Aitkenvale Drain;

A summary of the key flooding issues within the Aitkenvale/Mundingburra area relative to the ARI of floods is provided in **Table 5-2** following inspection of the flood mapping as presented in **Appendix D**.

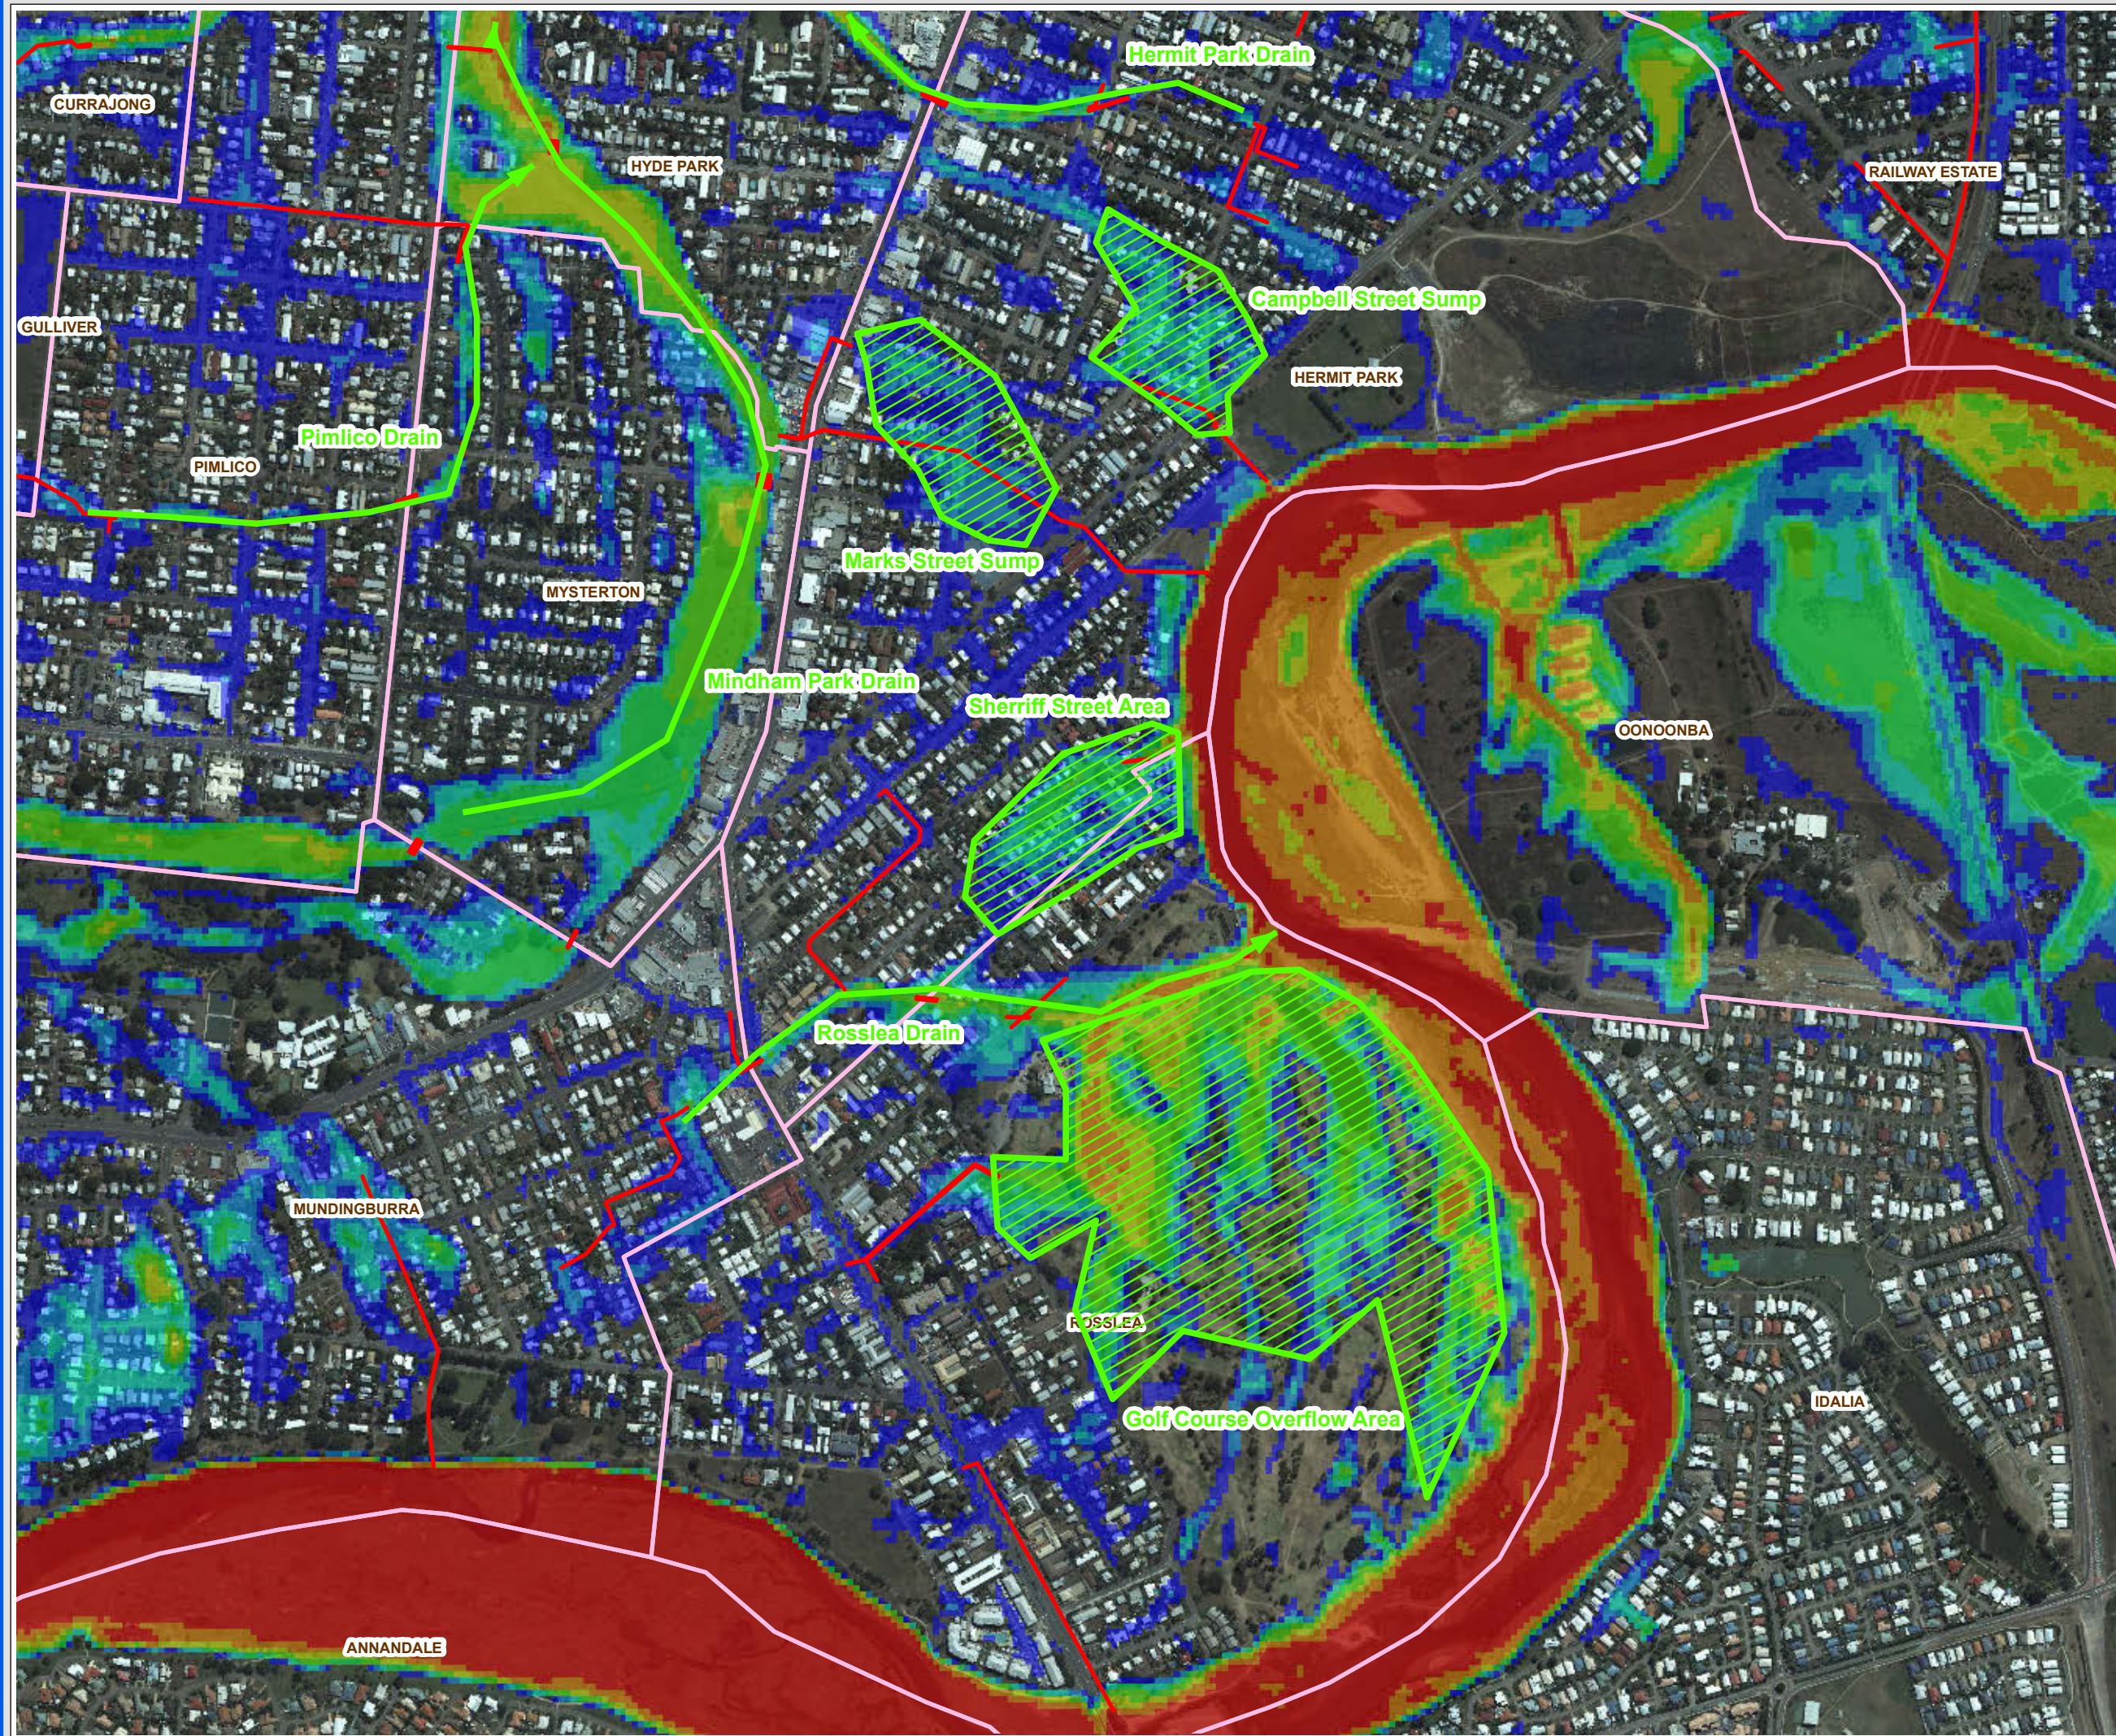
# ROSS CREEK FLOOD STUDY KEY FEATURES

**Figure 5-3** outlines the key drainage features of the Rosslea/Mysterton/Hermit Park area. There are a series of major open drains and major flow paths for the area:

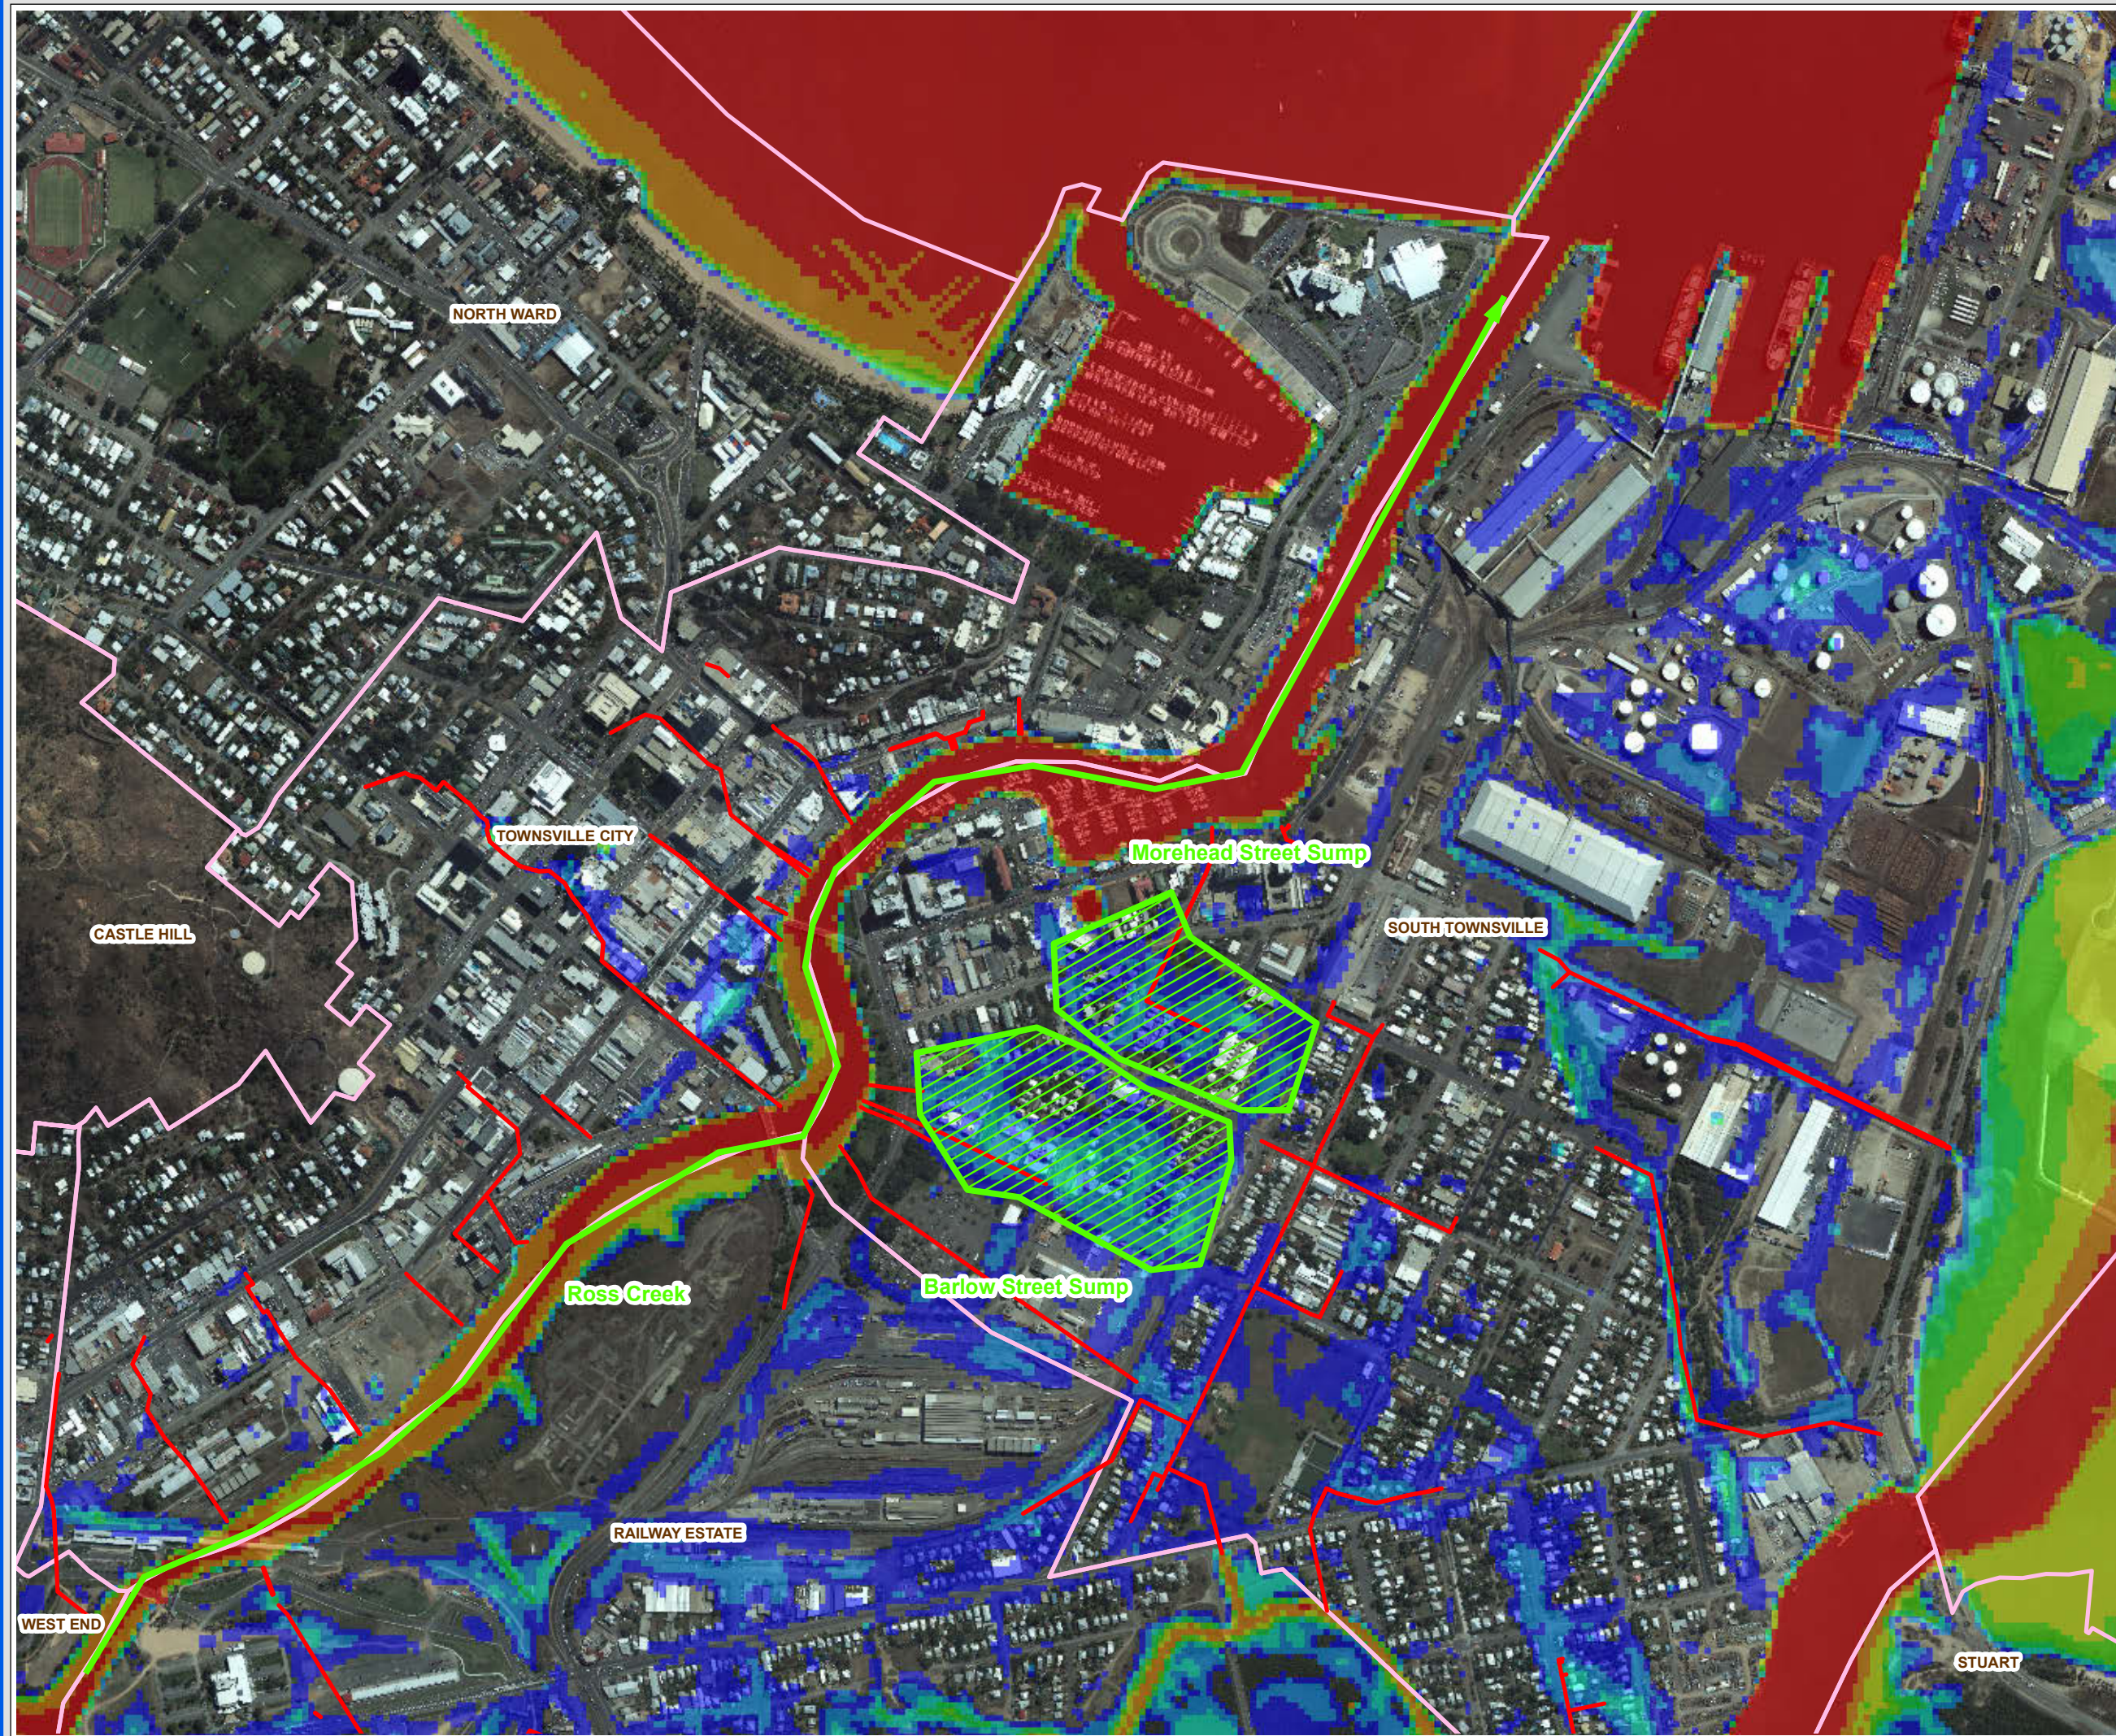
**ROSS CREEK  
FLOOD STUDY  
KEY FEATURES**  
Figure 5-8  
Townsville City

**Figure 5-8** outlines the key drainage features of the Townsville City area. The estuary of Ross Creek traverses through Townsville City before discharging to Cleveland Bay. In the lower reaches, tail water levels become the dominant influence on flood levels and Storm Tides independent of flooding are likely to produce higher water levels. The central business district is on the north-western bank of Ross Creek and back up the slopes Castle Hill, Stanton Hill and Melton Hill. Local catchments from the CBD are steep and generally have short response times.

A summary of the key flooding issues within the Townsville City area relative to the ARI of floods is provided in **Table 5-8** following inspection of the flood mapping as presented in **Appendix D**.
